First-year performance of a pumped, cold-climate woodchip bioreactor #35

Dept. of Soil, Water and Climate & Northwest Research and Outreach Center
University of Minnesota Twin Cities

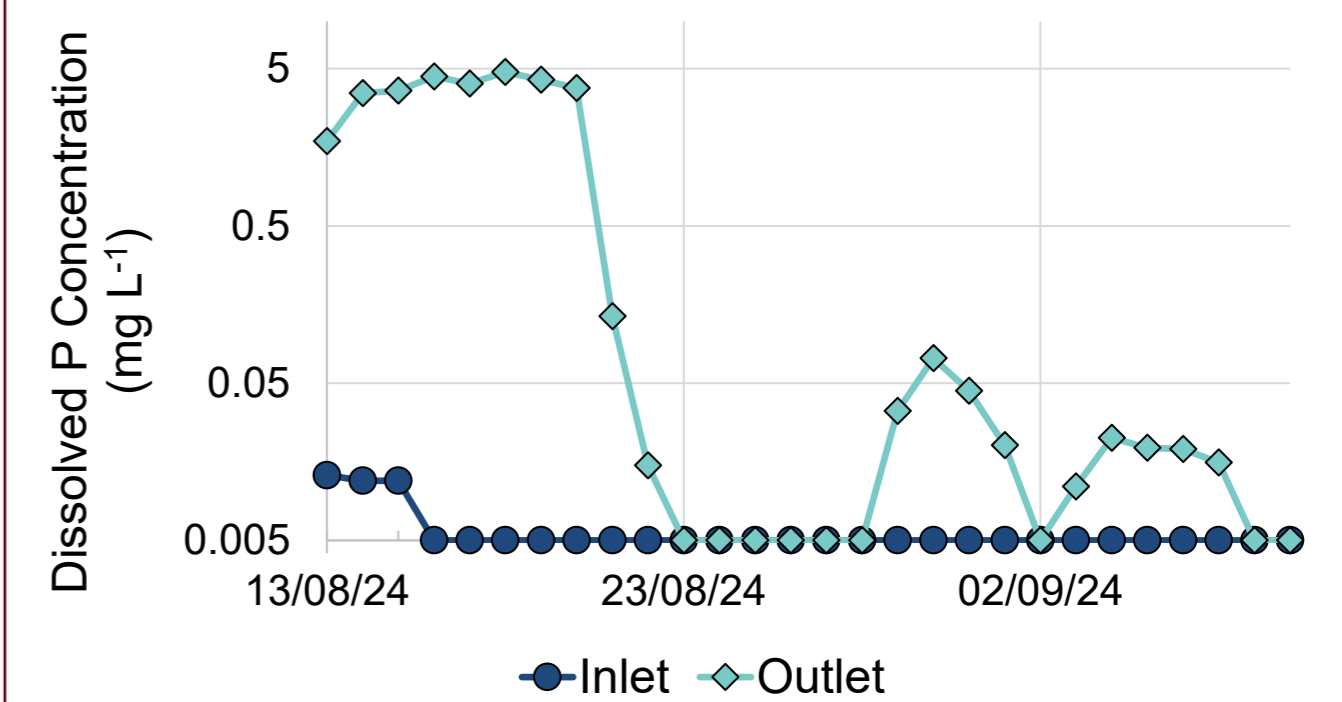
- Dissolved P concentrations averaged 0.01 mg L⁻¹ at the inlet and 1.09 mg L⁻¹ at the outlet
- Concentrations peaked 4.75 mg L⁻¹ but lessened after the first initial flush
